Fatalities #13 - August 18, 2005
Machinery - Surface - PA
Thomas J. Smith, Inc. - Smith No. 1 Mine

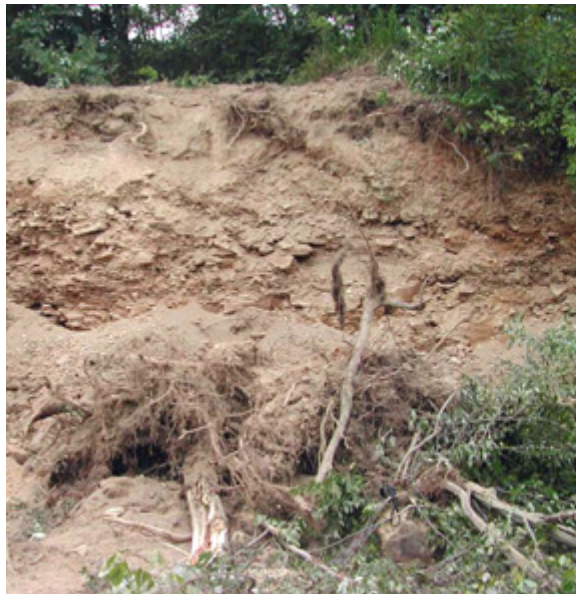
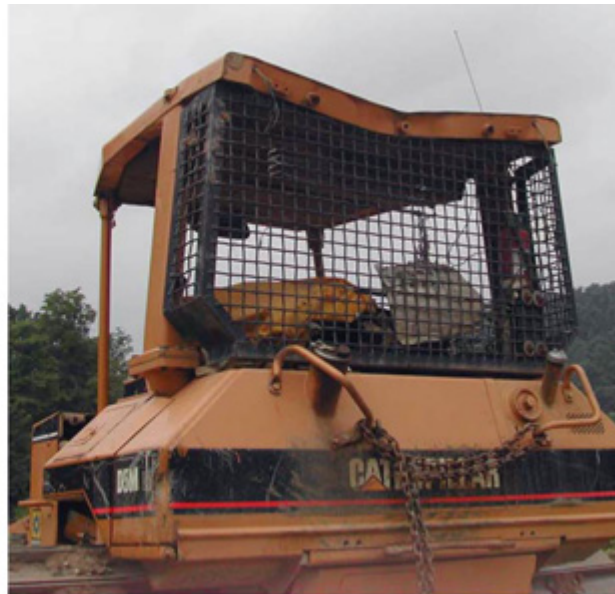
COAL MINE FATALITY - On Thursday, August 18, 2005, a 50-year old foreman with 26 years of mining experience was fatally injured while operating a Caterpillar D5M bulldozer. The foreman was using the bulldozer to clear trees on top of a 24-foot high embankment to facilitate construction of a haul road. While he was pushing material toward the edge, the bulldozer traveled over the crest of the embankment, coming to rest on its side.

- Stop, Look, Analyze, and Manage (SLAM) each task.
- Ensure that miners wear seatbelts when operating mobile equipment.
- Prior to working near embankments, check the crest and face of the slope for brows, rutting, cracking, slumping, or other indications that the material near the edge may be too weak to support the equipment.
- Conduct clearing and grubbing above highwalls, pits, or slopes at a safe distance from the crest. The crest should not be advanced into an area which has not been cleared. Large roots can extend several feet from a stump, which can remove or soften ground during extraction.
- Perform additional checks during the work shift to ensure ground conditions have not changed when the edge of a slope is not viewable from the operator's position.
- Inspect ground conditions from above and at the toe of the slope.
